Oxbow Lake

Aquatic Plant Management Plan – 3rd edition

White Water Associates, Inc.

Date: April 3, 2026

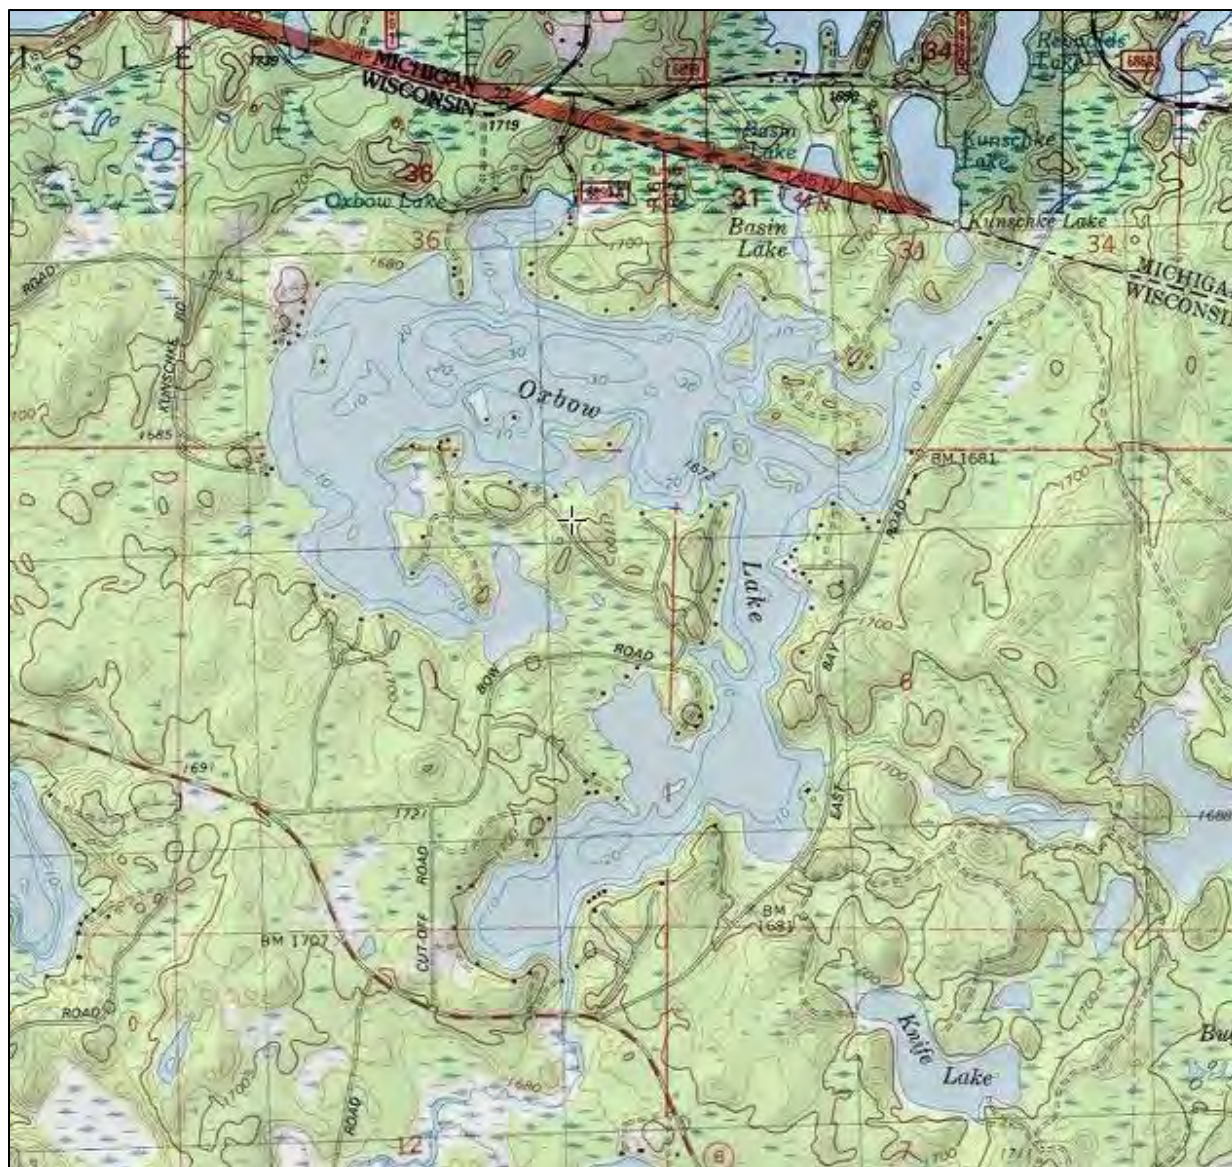
Map 3. Topographic map of Oxbow Lake.

Oxbow Lake has one public access site. A total of 98 piers on the shoreline of Oxbow Lake was observed from recent aerial photography or about 7.3 piers per mile of shoreline. The riparian area is of high quality and undisturbed in many areas. It consists of both upland and wetland areas (Map 3).

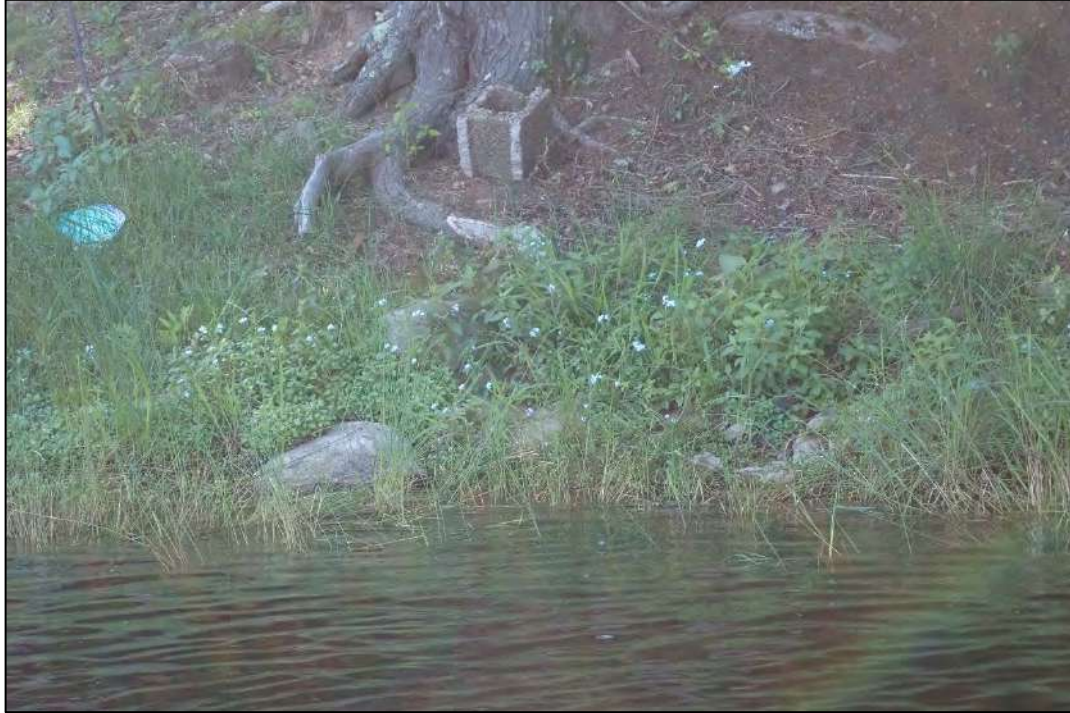
Photo 1. Aquatic forget-me-not (tiny blue flowers) on a northern Wisconsin Lake shoreline.

1. **Aquatic forget-me-not** (Photo 1). This invasive species can quickly crowd native plant species and is able to form large monocultures. This, in turn, affects community compositions by reducing the number of native herbs (Wisconsin DNR, 2025). Aquatic forget-me-not is difficult to control due to its mechanisms for spreading (Wisconsin DNR, 2025). Aquatic forget-me-not was found at one location during the 2024 AIS survey (Map 2).

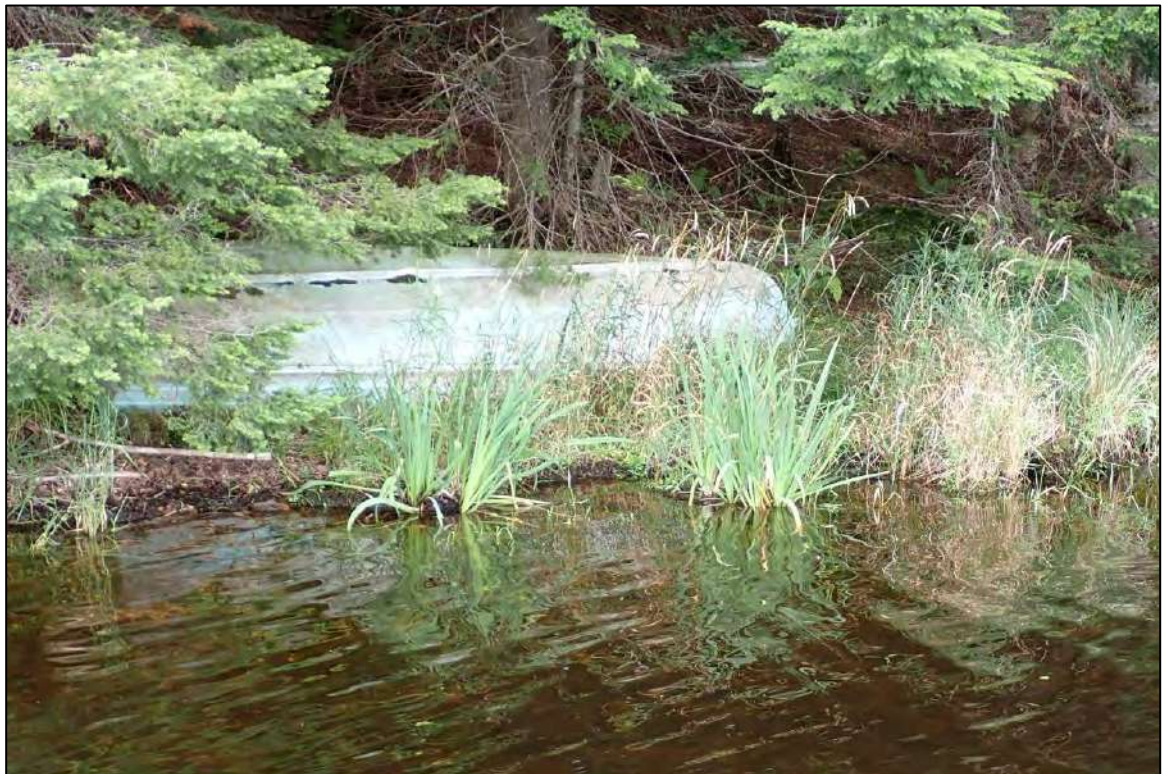
Photo 2. Possible yellow iris found on a northern Wisconsin Lake shoreline.

2. **Yellow iris**. At the time of the 2024 survey, iris plants were not in flower making definitive species identification impossible (Photo 2). The locations of the iris found are shown in the Map 2. We recommend monitoring the population annually in the spring (June) to confirm the presence of yellow iris by the blossom color. If yellow iris plants are present, they should be removed by digging up the entire plant (including the underground rhizome). To stabilize the resulting disturbed shoreline, we recommend that native blue flag iris (*Iris versicolor*) be planted. This species is available from nurseries.
